# Two Years of Making PCIe “Hotplug” Reliable: What Landed, What Didn't, and Where Do We Go

Maciej Grochowski · SONY SIE · LPC 2026

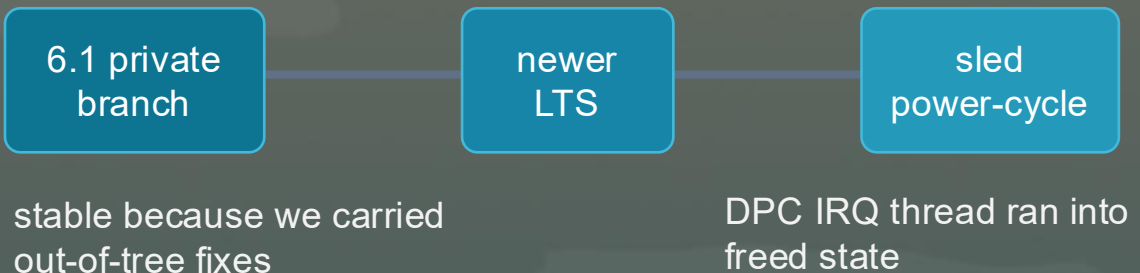
Enumeration was clean; DPC recovery exposed a lifetime bug

```
BUG: kernel NULL pointer dereference @ 0x10
RIP: pci_dev_wait+0x45
    pci_bridge_wait_for_secondary_bus
    dpc_reset_link → pcie_do_recovery →
dpc_handler
kernel tried to execute NX-protected page
"Fixing recursive fault but reboot is needed!"
```

- enumeration and hotplug looked clean
- DPC recovery hit UAF
- upstream already had parts of the fix

**The crash was easy to read.  
The cause sat three layers down.**

- backport gap, not a new discovery
- correct commit looked like the culprit
- field mitigation re-armed a related bug

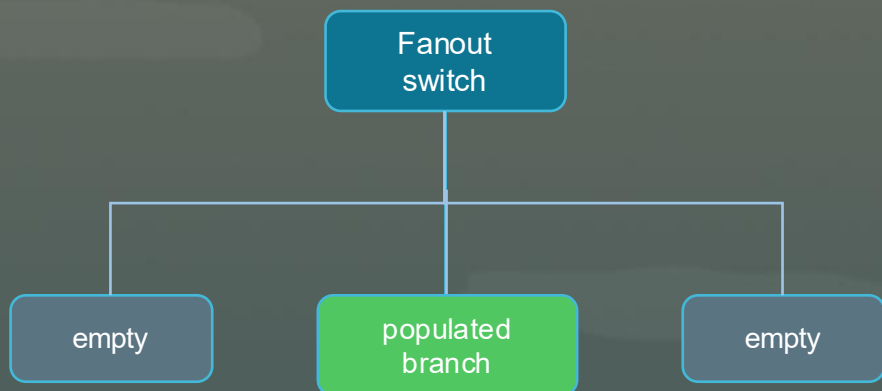
## Issue A · equal-split starvation

Linux split ~1032 MiB equally across 5 hotplug siblings: ~206 MiB each. Populated branch needs the full 1032 MiB for a 1 GiB-aligned BAR.

Root cause: equal distribution, not need-based sizing.

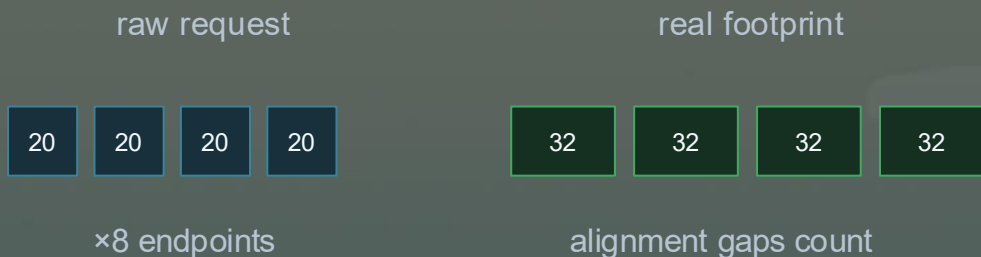
## Issue B · alignment-gap undersizing

```
sum: 8×20 = 160 MiB  
real: 8×32 = 256 MiB  
3 of 8 endpoints get no BAR
```

Both bugs scale against Gen6 endpoint density.

```
Stopgap: size += ALIGN(r_size, align)
```
